SIZING RIPRAP FOR THE PROTECTION OF APPROACH EMBANKMENTS & SPUR DIKES AND LIMITING THE DEPTH OF SCOUR AT BRIDGE PIERS & ABUTMENTS

Volume I: Literature Review & Arizona Case Histories

Prepared by:
Simons, LI & Associates, Inc.
4600 South Mill Avenue, Suite 280
Tempe, Arizona 85282

June 1989

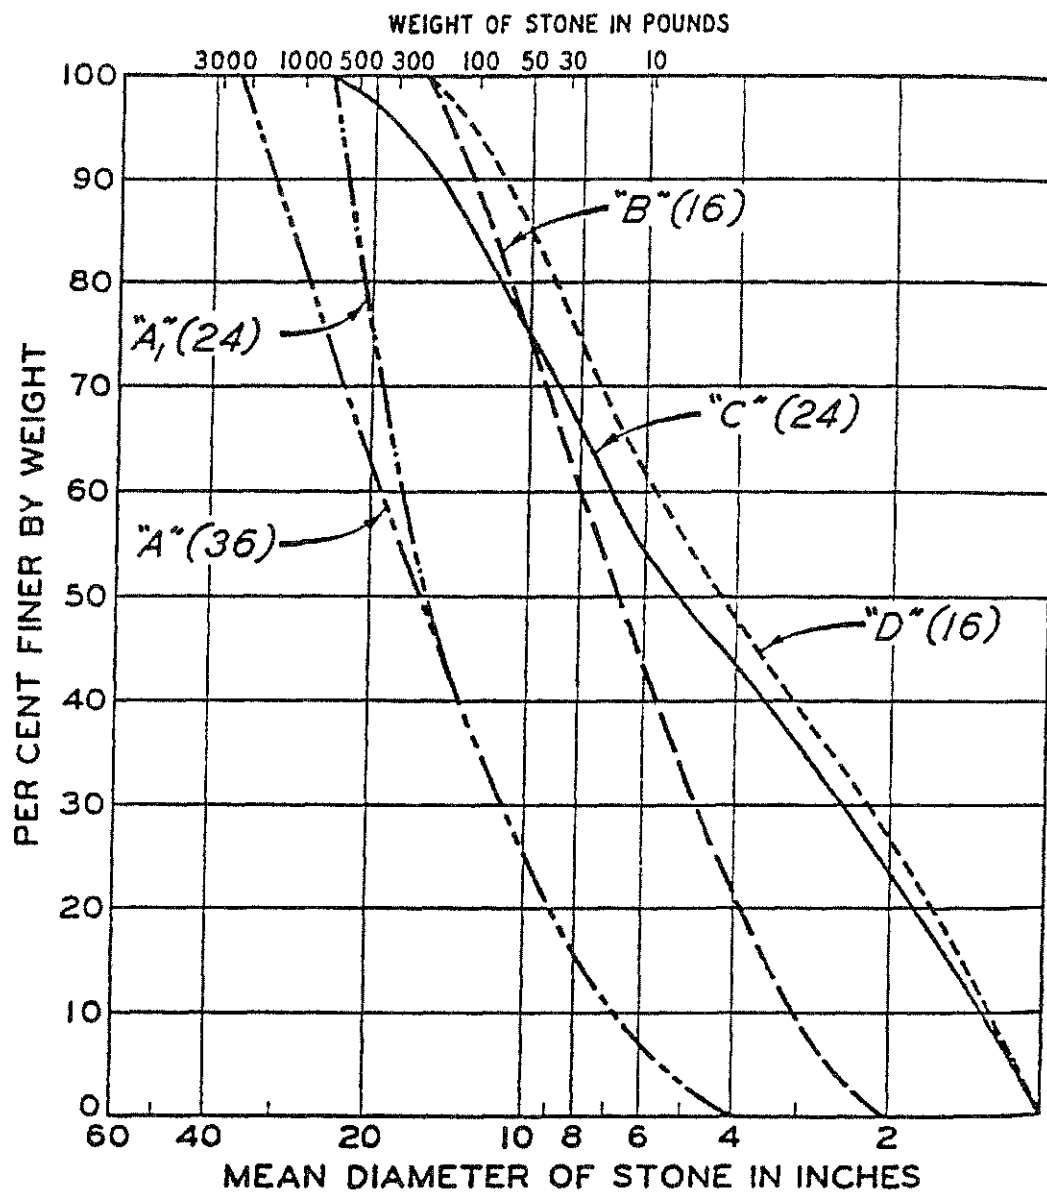
Figure 1. Riprap Gradations Tested by Murphy and Grace (1963)

Murphy and Grave (1963) tested various rock sizes and gradations in conjunction with protection of overflow dikes. Two gradations, A and A1 (Figure 1), failed under the same conditions although gradation A had maximum particles 36 inches in diameter as opposed to 24 inches for gradation A1. Both gradations had a median diameter of 16 inches. The two gradations B and C, failed under the same conditions. The greater variation in particle sizes in the C gradation resulted in a maximum size of 24 inches compared to 16 inches for the B gradation. However, only 15 percent of the B gradation was less than half the D_{50} , compared to 30 percent for the C gradation. In the model test, it was found that riprap failure occurred by removal of smaller particles, resulting in the dislodgement of larger particles. Murphy and Grace concluded that stones larger than some critical size (approximately D_{65} in their tests), do not increase riprap stability.

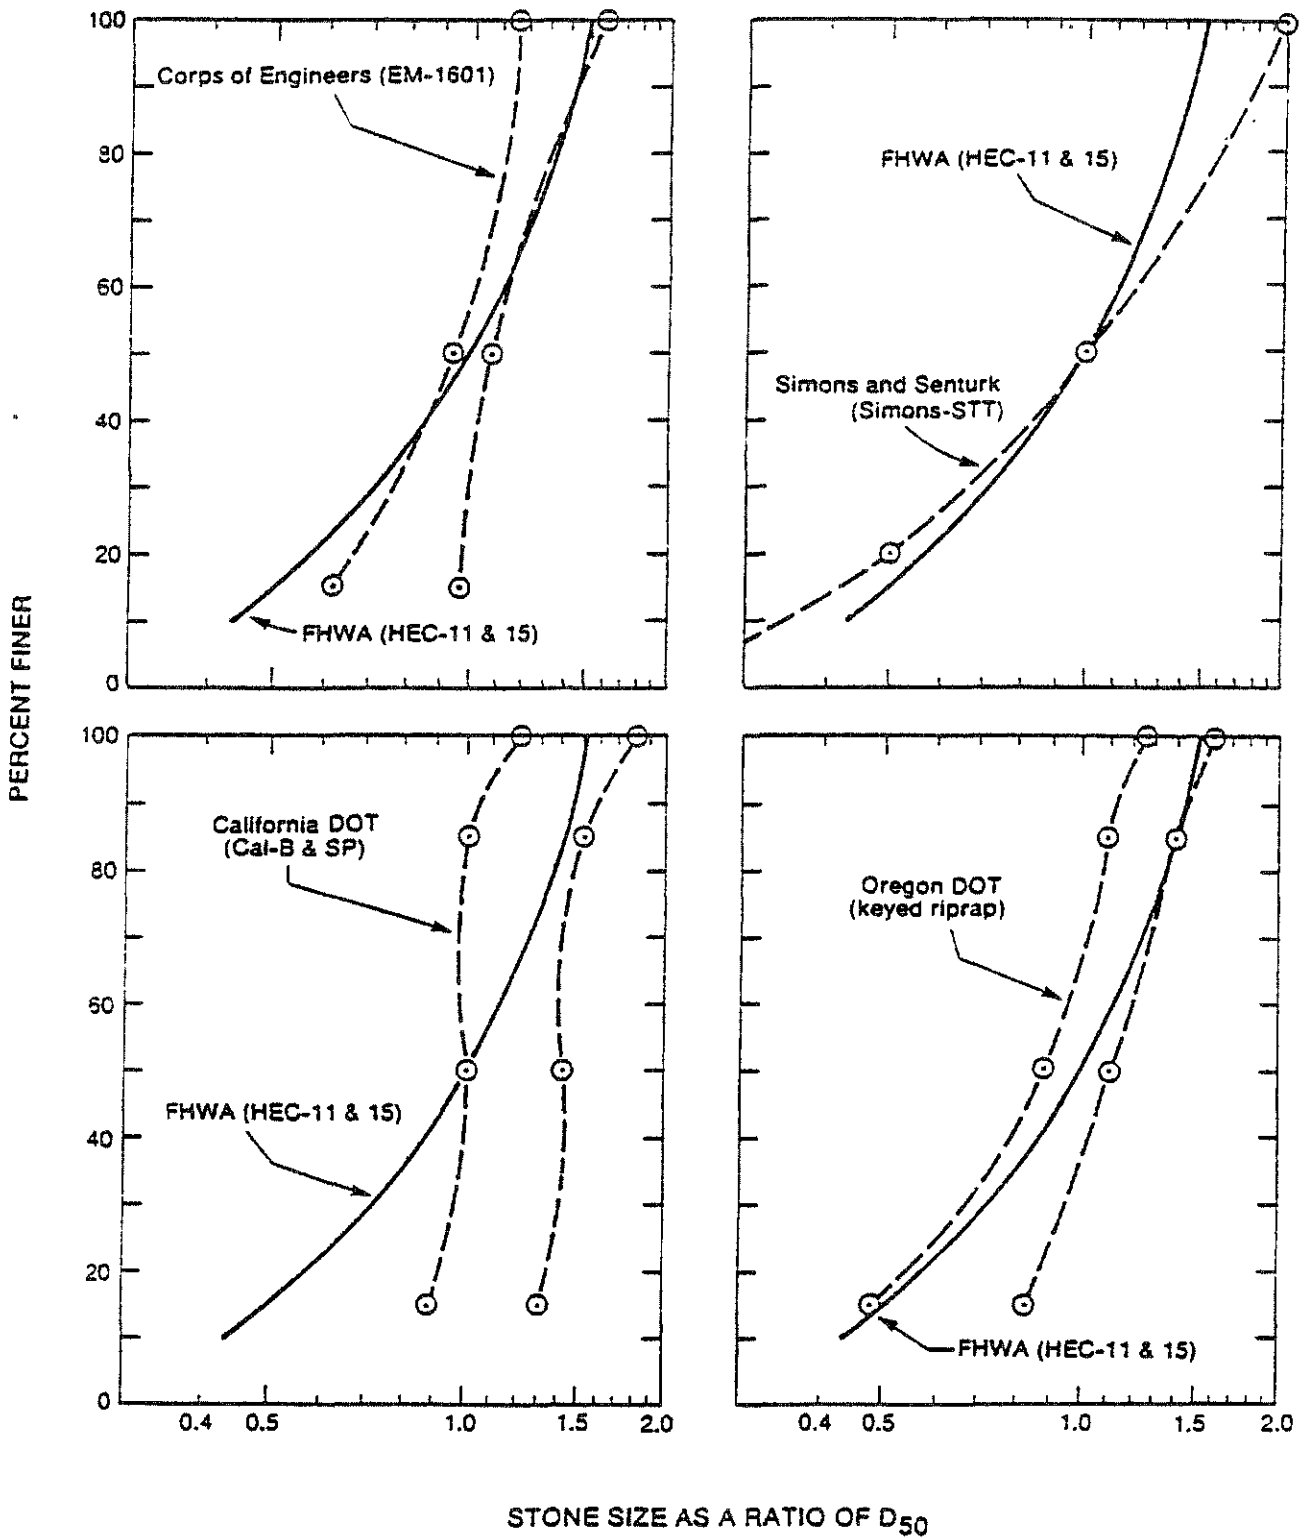
Figure 2. Comparison of Specified Riprap Gradations, Blodgett and McConaughy (1986)

Blodgett and McConaughy (1986) compare stone gradations specified in different design procedures. Figure 2 presents their comparison and includes Oregon and California specifications.

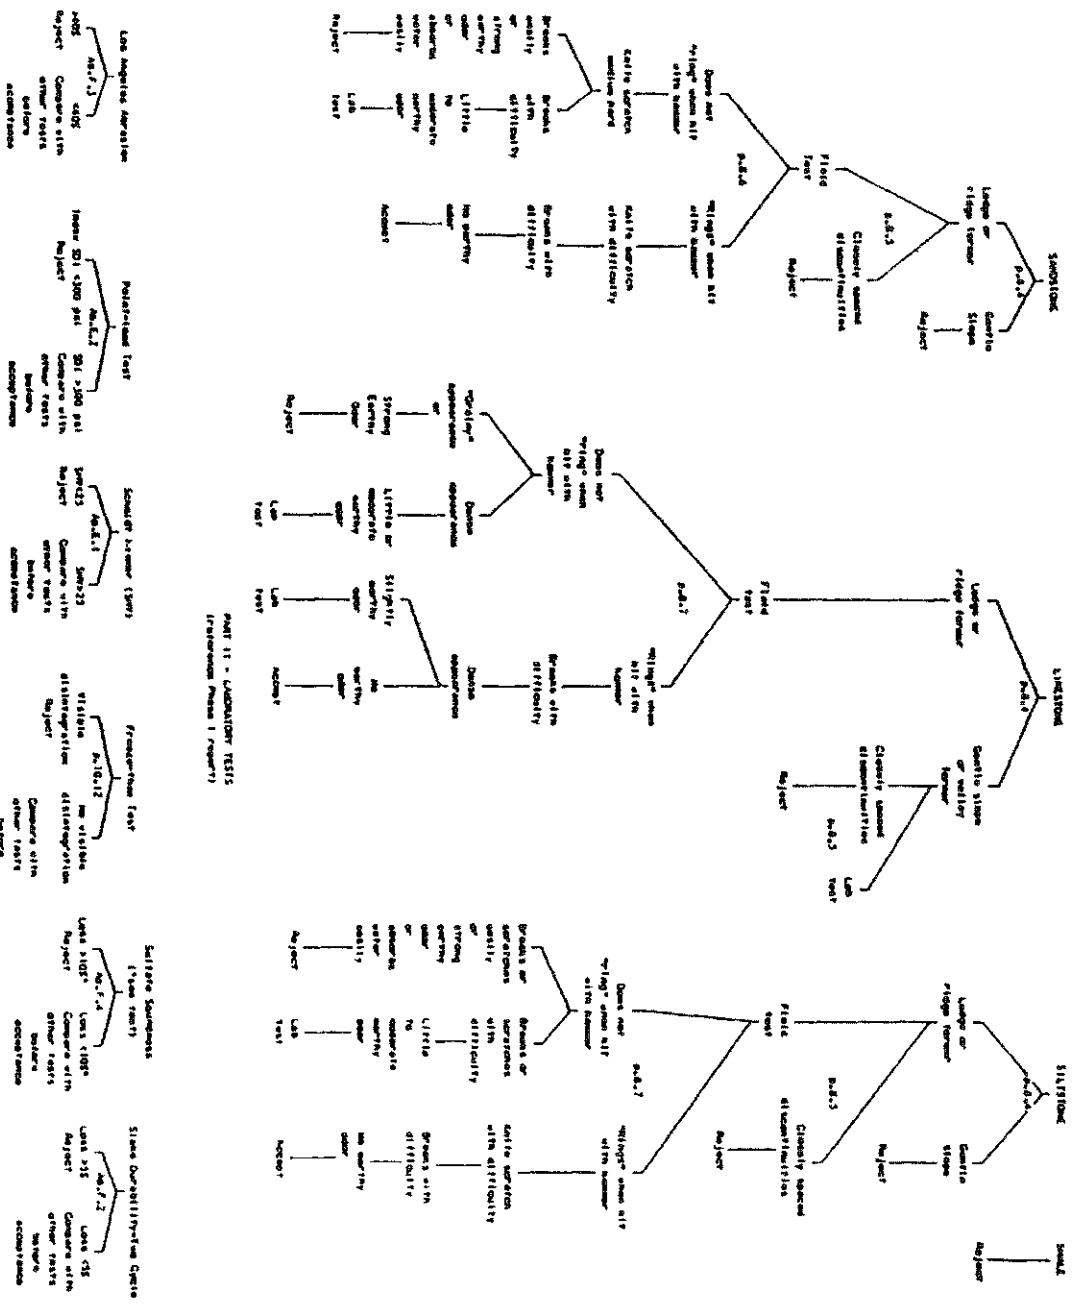
Figure 3. Rock Durability Flow Chart, Summers and Johnson (1982)

Abrasion, Point-load test, Schmidt hammer, freeze-thaw test, sulfate soundness test, and slake durability-two cycle (ASTM, 1980). Summer and Johnson (1982) devised a rock durability flow chart, which provides a procedure for evaluating rock suitability as riprap for channel lining. This procedure incorporates both site investigation and laboratory testing as required, and is a simple step-by-step approach (Figure 3). Smith, McCauley and Mearns (1970) studied quality control of riprap by the California Division of Highways and recommended the durability absorption ratio (DAR) as the best means of combining the results of inexpensive laboratory tests into an index usable for specifying riprap durability.

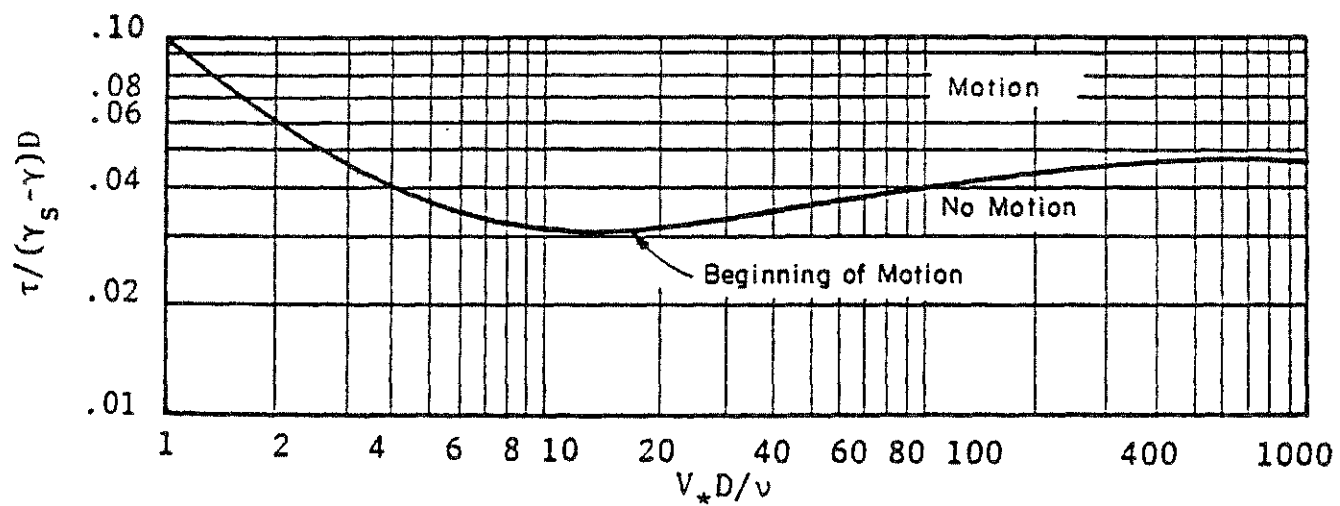
Figure 4. Shields Diagram (after Gessler, 1971)

The flow condition which just sets a solid particle in motion is the primary criteria used in riprap design. Shields (1936) conducted experiments with uniform sediment sizes to develop his well-known incipient motion diagram, which is shown in Figure 4. The Shields diagram is a nondimensional chart with the vertical axis being the ratio of boundary-shear stress to particle weight, and the horizontal axis being the particle Reynolds number. Laboratory data on the incipient motion of nonuniform size distributions has been collected by Gessler (1963) and by Little and Mayer (1972). Gessler (1971) noted that because of fluctuations in turbulence intensity and the nonuniformity of channel bed material, that Shields criteria must be viewed in a probabilistic manner. Shen and Lu (1983) developed a procedure for predicting the final imposition of armoring bed. They found that D_{30} should

be used to substitute for the uniform sediment size in the Shields diagram to describe incipient motion.

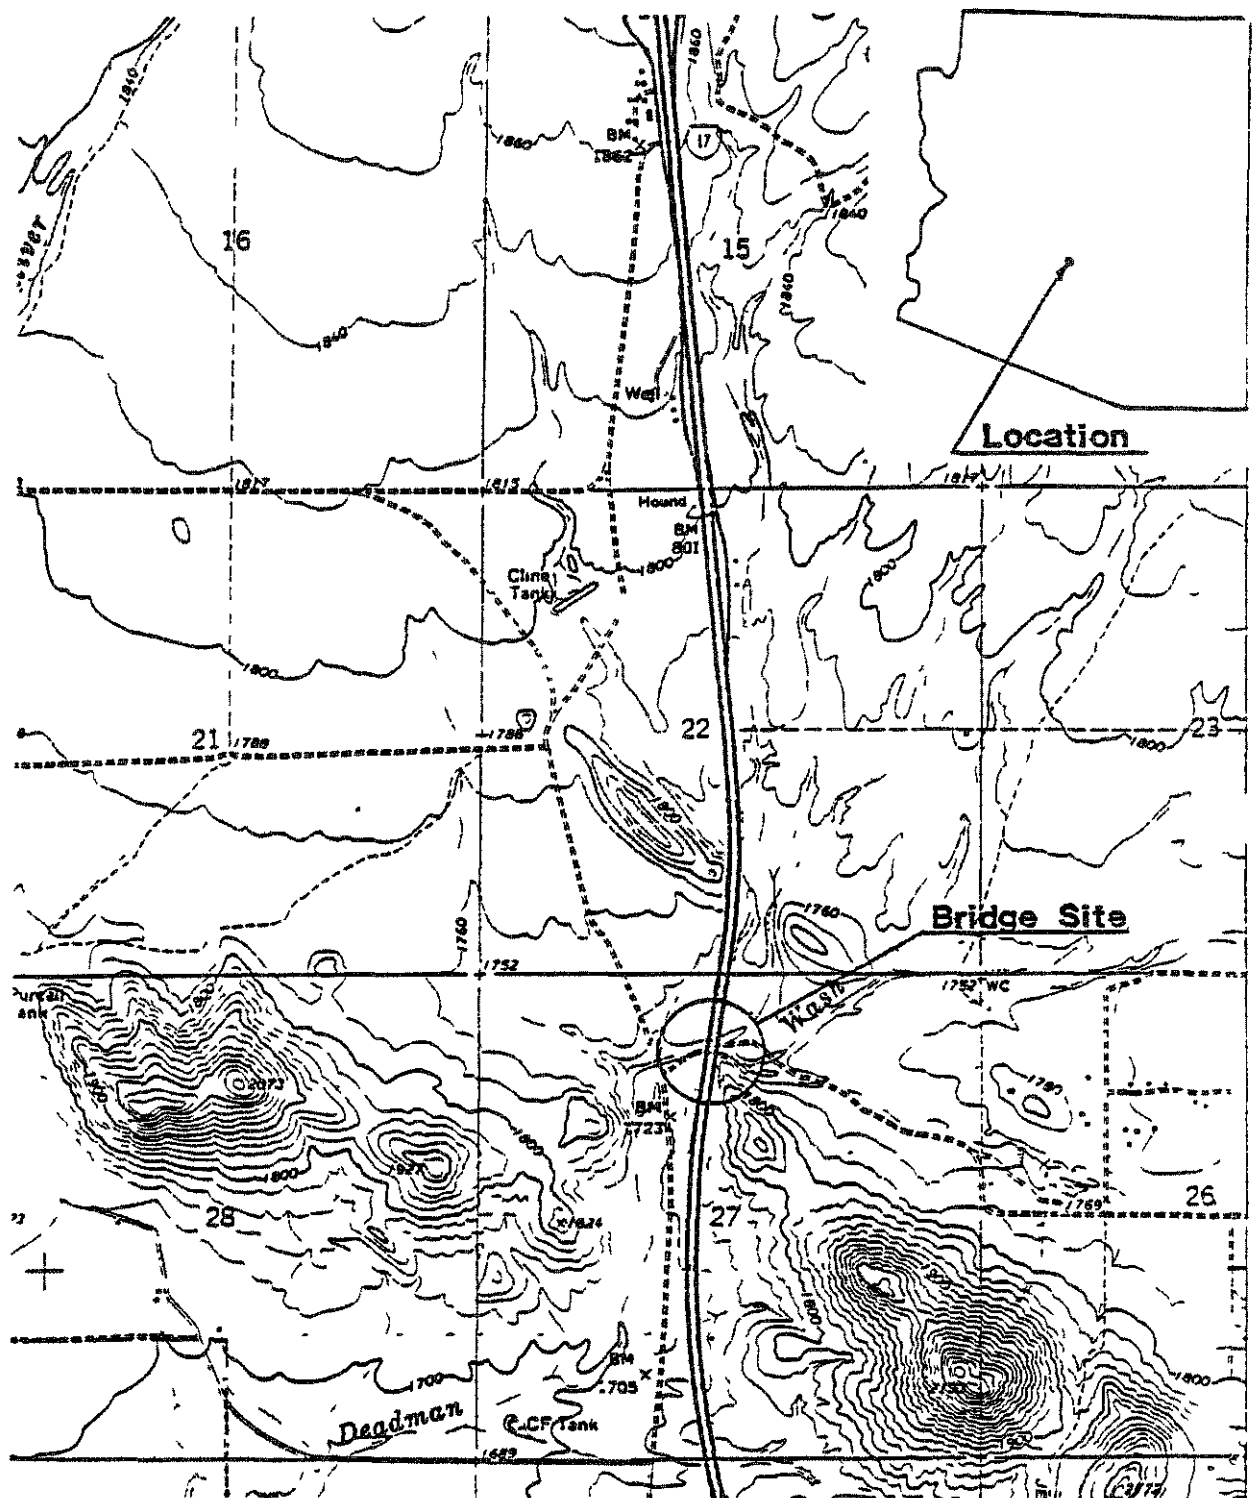
CASE HISTORY NO. 2
Deadman Wash
Route: 1-17

The inspection reports state that there has been little flow and little alteration to the riprap mattress.

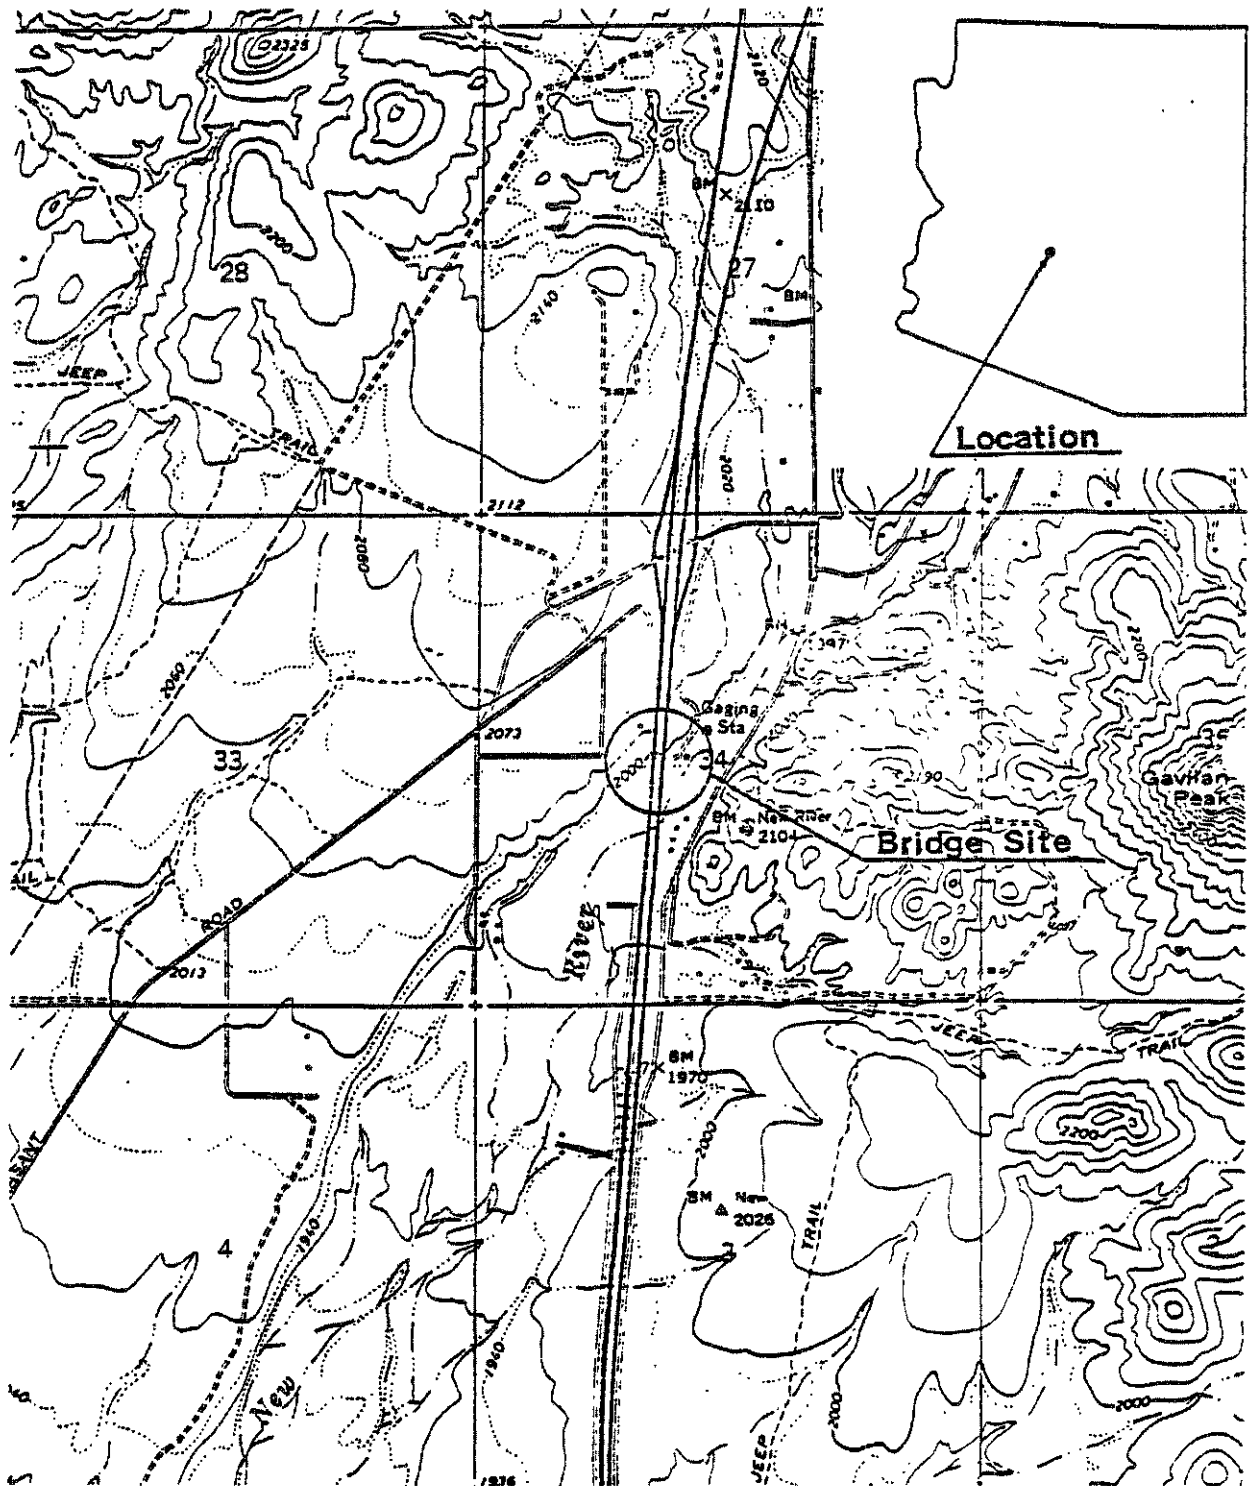
CASE HISTORY NO. 3
New River
Route: 1-17

Bridge inspection report says the channel has remained relatively stable since last inspection; minor loss of material at piers 4, 5, and 6 is no problem at this time.

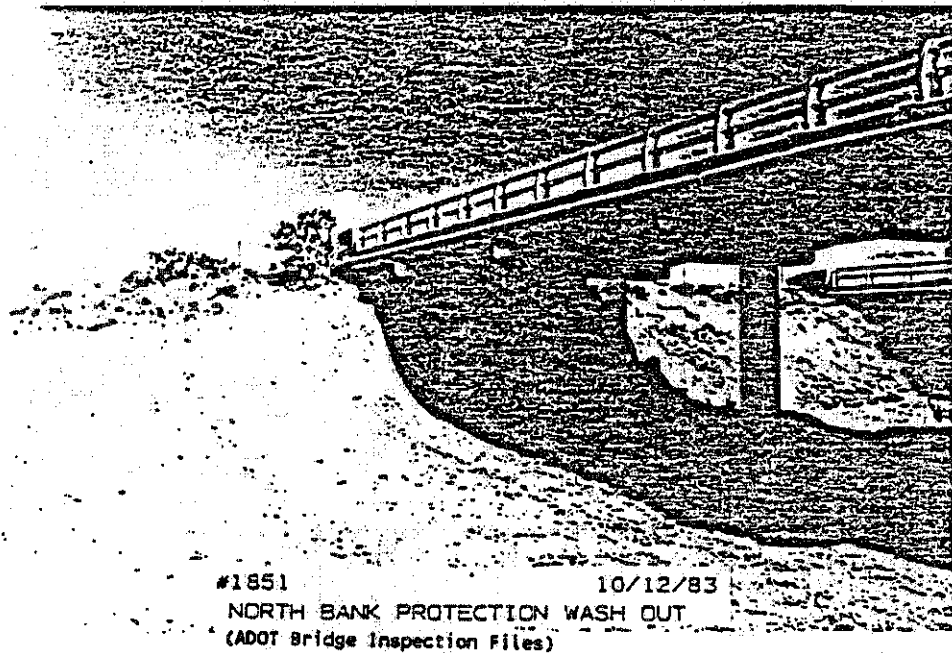
1. The integrity of the C-17.02 channel checks and wire-tied aprons were suspect because of corroded and broken wire.
2. The north side of the channel check had no cable lacing between the rails, possibly due to scour damage.

The following recommendations were made: Repair or replace the existing grade control structure, and continue to refrain from excavating below the streambed in pit #7008.
